**AFRL-VA-WP-TR-2000-3031**

**STANDARD BONDED REPAIRS FOR  
CORROSION DAMAGE**

## **Standard Bonded Repairs for Corrosion Damage**

Advanced Repair Technology International

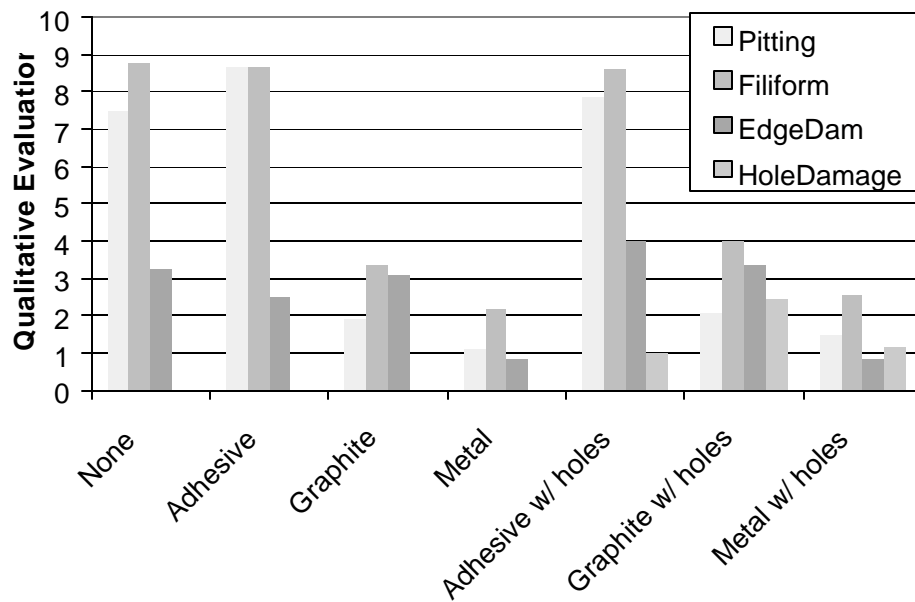
Figure 7: Qualitative evaluation of repaired specimens

The adhesive-only specimens showed pitting and filiform damage. The damage was not nearly as severe as the non-repaired specimens, but was more severe than any of the repaired specimens. Again, this was as predicted. Notably however, the damage was diffused rather than primarily located at the water line.

The graphite repair specimens showed small amounts of pitting and filiform corrosion, but an inordinate amount of edge damage. Some specimens exhibited complete exfoliation from the edges that reduced the total area by up to 10%. In areas not affected by either edge or hole initiated corrosion there was very little, if any corrosion damage. Figure 7 shows the average qualitative damage levels of each specimen type.

The metal repair specimens showed very little corrosion damage. There was a small amount of filiform, and a few very small pits on some samples, but the majority of specimens showed practically no damage. The damage that was present initiated on the edges and at the holes.

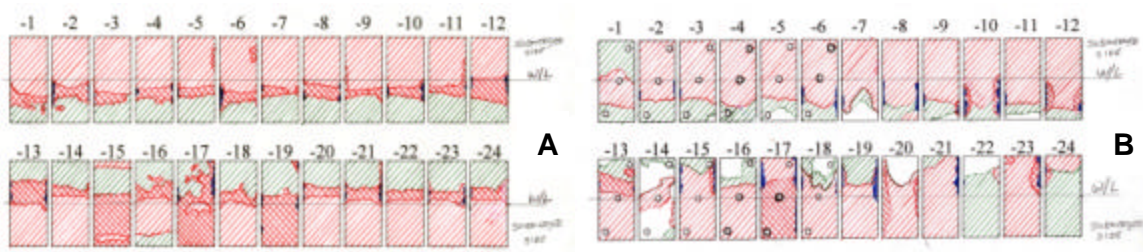
Figure 8: Damage Maps - A) no repair B) adhesive

Damage maps of all the specimens are shown in Figure 8 and Figure 9. Qualitative average damage assessments are shown for all specimens in Table 5 and Table 6.

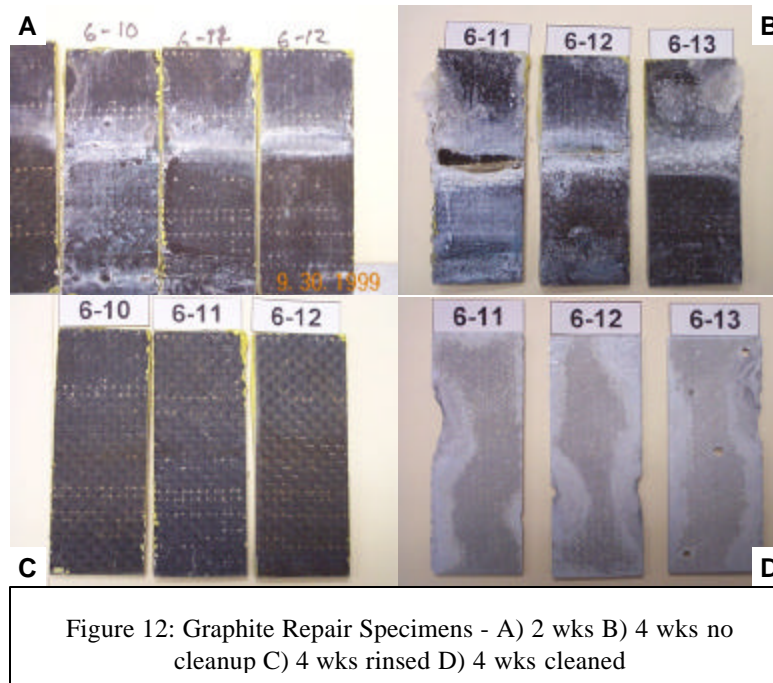
For example, the graphite specimens from the repair evaluation phase were damaged not by moisture penetrating the repair material and adhesive layer, but through the repair edges. The excessive edge damage can be traced to the way the specimens were fabricated. The repaired panel was cut using a band saw moving from the graphite through the aluminum. Although the specimen edges were protected by a thin layer of epoxy-polyamide primer, graphite fiber and dust was most likely embedded in the edges of the aluminum during the cutting process and then painted over with primer. This formed a galvanic couple, which ate away at the metal edges causing cracks in the primer layer and allowing direct exposure to the CASS solution. The addition of the corrosive fluid to the existing galvanic couple created a dynamic corrosion environment that destroyed the edges of some of the graphite specimens. It is important to note however that even on specimens with very bad edge or hole damage, there were portions of the specimens that were almost completely undamaged. The moisture that propagated through the adhesive was not enough to initiate corrosion, or cause previously repaired microscopic corrosion pits to re-initiate. These results clearly show how important it is that poor machining technique or inadequate cleanup is not allowed to create a galvanic couple.

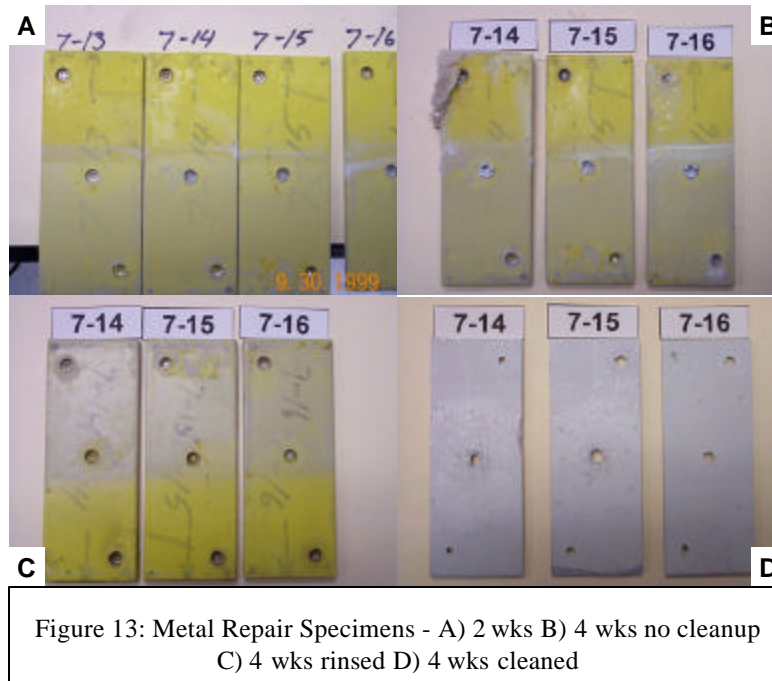
The metal to metal bonded repair reinforced the belief that bonded repairs are good choices for corrosion sensitive areas. The metal and adhesive provided a very successful barrier against moisture ingress and without an electrolyte, corrosion becomes next to impossible. The only signs of damage on the metal specimens were where moisture was allowed direct access to the specimens through holes, simulating unsealed rivet holes, or poor sealing around the edges. Even when access was permitted; no major corrosion damage was present. The results of the non-repaired specimens show that this was a fairly extreme environment, which only further highlights the lack of significant corrosion damage on the metal and graphite coupons. Even the adhesive-only specimens showed a dramatic increase in protection over the non-repaired specimens.

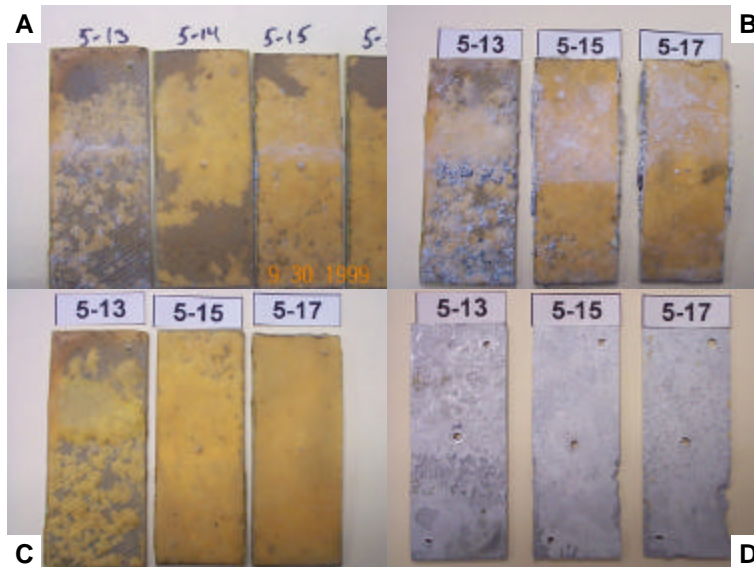
Figure 14: Adhesive Repair Specimens - A) 2 wks B) 4 wks no cleanup C) 4 wks rinsed D) 4 wks cleaned

It is also important to note the type of corrosion growth that occurred. Around the edges and holes, exfoliation was the primary mode of corrosion. That was expected since 7075-T6 is notoriously susceptible to exfoliation when edges or grain boundaries are exposed. More interestingly however was the apparent corrosion 'order of battle'. Filiform type corrosion seemed to occur before pitting in almost every specimen. Wherever pits were evident, there was always peripheral filiform damage. In cases where pits were not visible, filiform damage was present. This was initially observed during the solution run-off testing where the specimens were examined daily. Filiform damage would start at the air/solution interface and spread from there. Pitting would then initiate from the area where filiform damage was most prevalent, and move following the same pattern as the filiform damage.

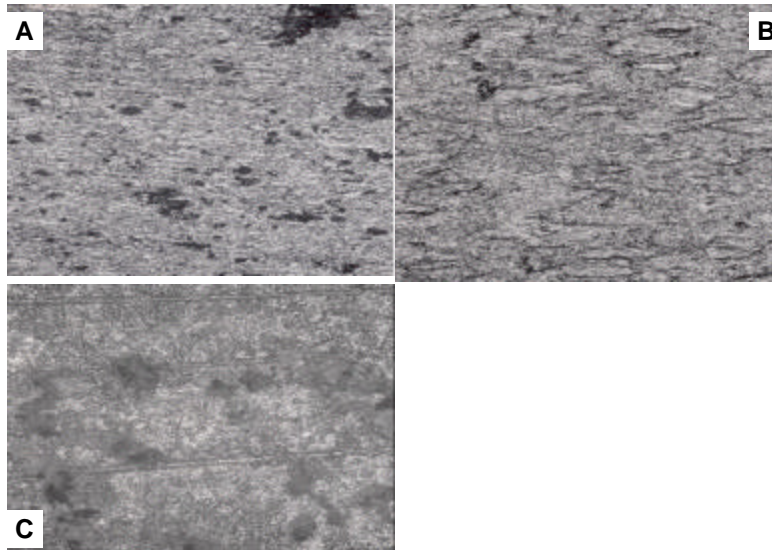
Figure 16: No Repair Specimen 8-12 – A) pre-corrosion B) solvent scrub C) 4 wks exposure

In addition, as shown in Figure 16 through Figure 18 (micrographs of corrosion damage that was then chemically and mechanically cleaned) microscopic corrosion pits remained even after thorough cleaning. The panels were all cleaned as if they were aircraft parts. The damage was completely removed using standard sheet metal techniques and there was no visible corrosion remaining. This damage however did not regrow after re-exposure to the corrosive fluid. This was due to the repair and adhesive providing an effective barrier against moisture ingress. A riveted repair, with more moisture access

points could not do as good of a job keeping moisture away from the remaining corrosion damage sites.
